A New Concept for Lightning Protection of Boats

Protect a Boat like a Building

Ewen M. Thomson, Ph.D.

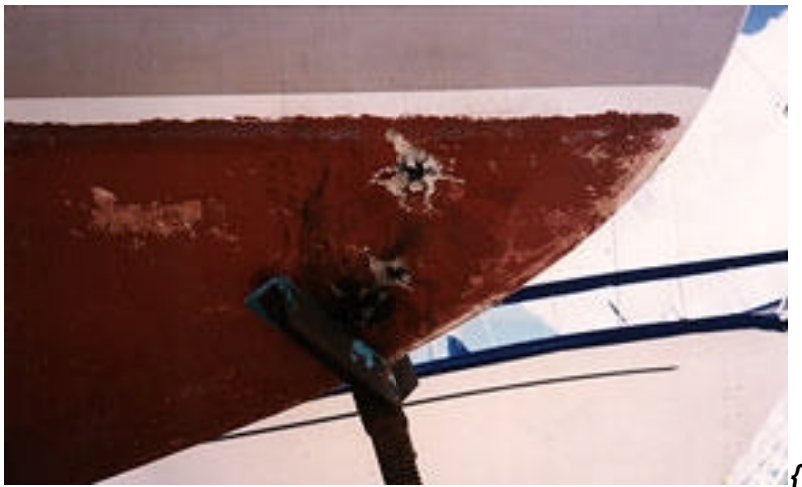
While there were a number of problems with the status quo (before NFPA780-2008), the major stumbling block was the mandate for a one square foot ground plate or strip. This was frequently interpreted to mean that that was all that was required and the best way to connect this was by the shortest path possible to a single air terminal on top of a mast. In my 1991 IEEE paper¹ I calculated what typical voltage the lightning protection system would reach if it were connected to a single immersed grounding conductor with a contact area of one square foot. In fresh water this voltage was found to be so large that sideflashes would be inevitable. (A side flash is an uncontrolled spark that carries current to the water and can do extensive damage to hulls and equipment.) This calculation was done to help explain observations of extensive sideflash damage in sailboats even when the mast was grounded to the keel or a ground plate. Cases such as that below from Boat US claim #950447 have necessitated a new term to be added to the glossary of lightning protection - a "supplemental grounding electrode" that conducts lightning current into the water in addition to that conducted by a main grounding electrode (or ground plate). In this case the anchor chain formed sideflashes through the hull causing extensive hull damage.

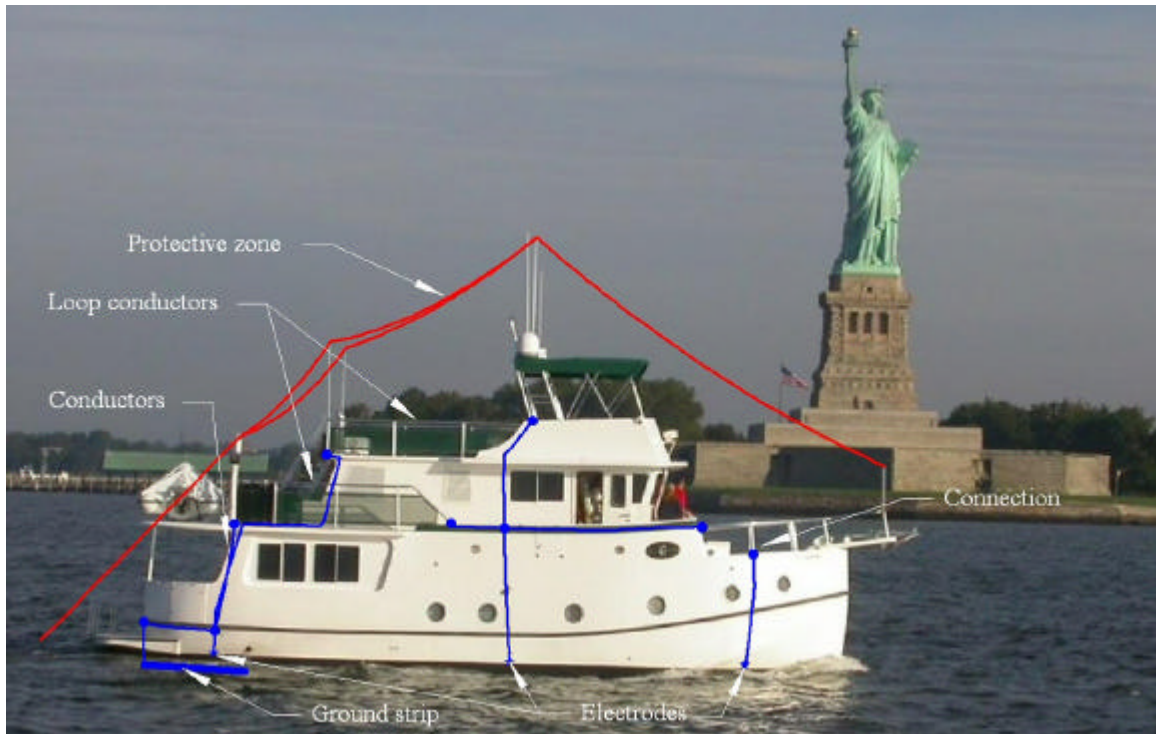
Lightning protection system on *John Henry*

We have applied all of these new concepts in *John Henry*, a Great Harbour 47' passagemaker built by Mirage Manufacturing and displayed in last year's Annapolis powerboat show. The annotated photo below shows the main features. The red lines show the total zone of protection using the rolling sphere method. Any person walking anywhere on the deck is inside this protective zone. In order to achieve this coverage we placed air terminals on the bow pulpit, on top of the fly bridge arch, and on top of the handrails at the rear of the fly bridge deck. We also connected the dinghy davit to the lightning protection system. The blue lines show the additional lightning conductors which were made of 2AWG tinned copper marine battery cable. These were connected to existing conducting fittings - the handrails on both main and fly bridge levels, and the bimini - to form two conducting loops, one around the main deck level and the other around the fly bridge deck. Down conductors connected to these loop conductors were run vertically down the inside of the hull and terminated at Siedarc™ grounding electrodes at six locations symmetrically distributed around the waterline. The patented Siedarc™ electrode is a customized fitting designed specifically for lightning grounding. Each of these was installed just above the black stripe. One square foot of immersed grounding area was provided by a grounding strip placed near the stern of the boat. This placement allowed the down conductor to this strip also to be run down the inside of the hull, external to all conducting fittings and equipment. As an additional precaution, all through bolts for the grounding strip were contained inside a watertight lazarette. The cost of such an installation is around \$6000-\$7000. *John Henry* has not been struck by lightning yet so that the effectiveness of this system has not been tested. And while *John Henry's* owner may hope the boat is never hit, we would find such a strike would add tremendously to current data.
